Robot-Welded Post Testing Performance Test Report

Rendered To:
STAR Systems International, LLC.

Report No.:
QCT23-6935.01

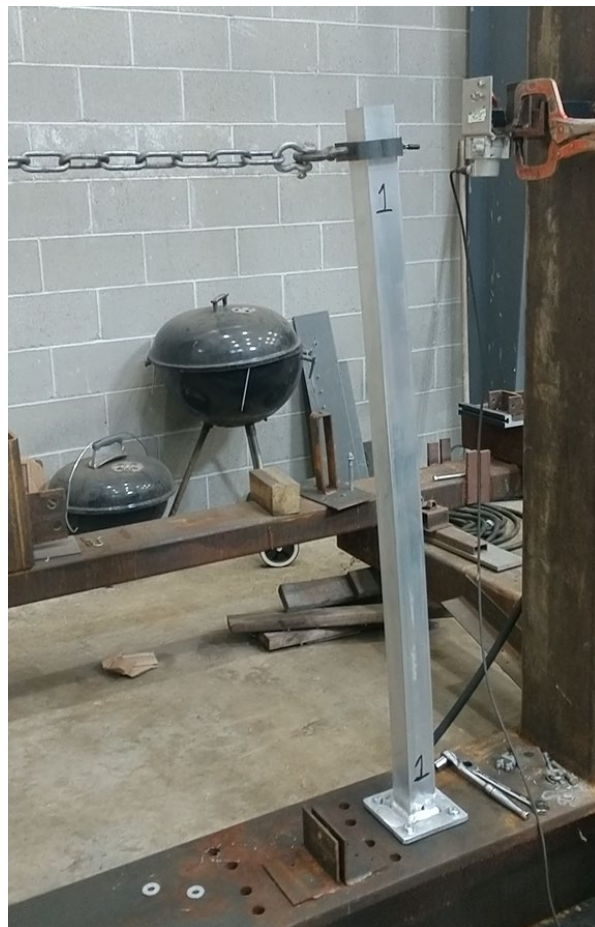
Photo #1: Post Setup

See Photo #1 for test setup and Photo #2 for pulling attachment. A horizontal load was applied 42" up from the base of the post using a hydraulic cylinder. Horizontal deflection at the point of load application was measured using a string potentiometer. Load vs Deflection graphs were generated for each test and are located in Appendix A. Photos of specimens after test are located in Appendix B.

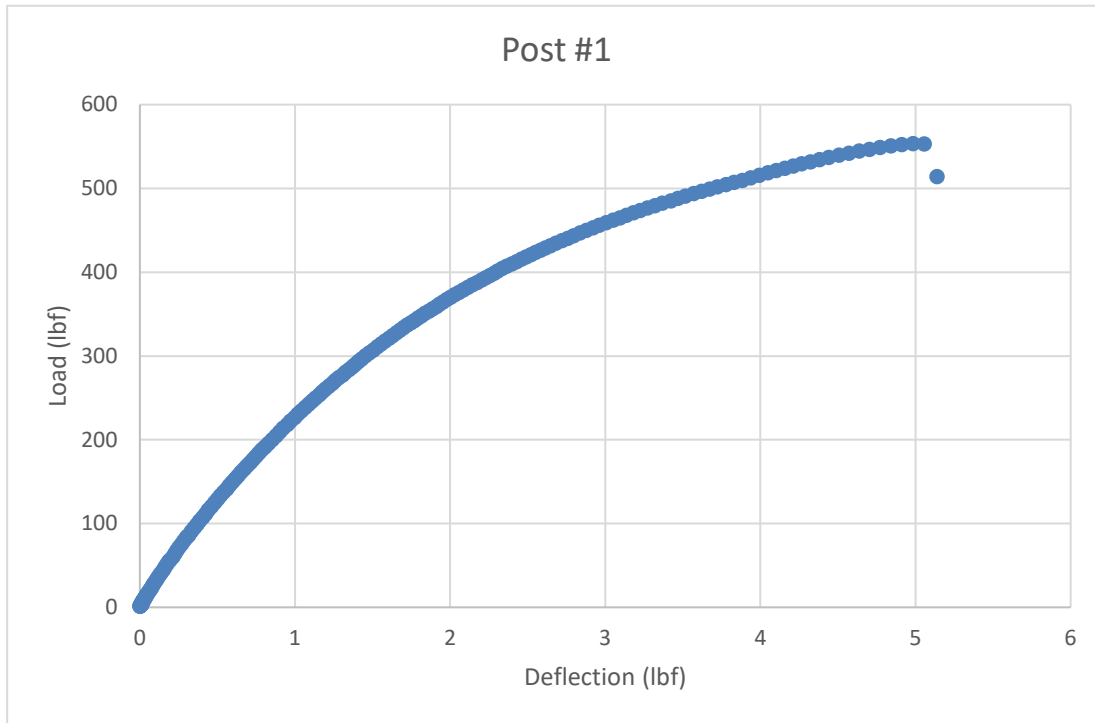
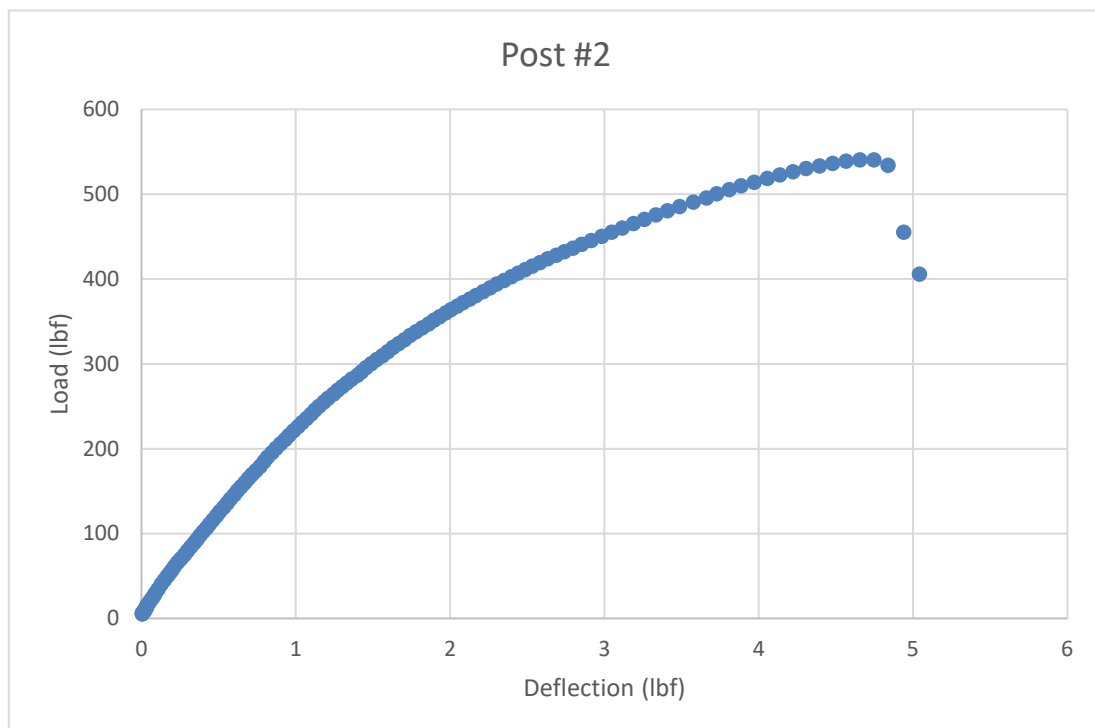
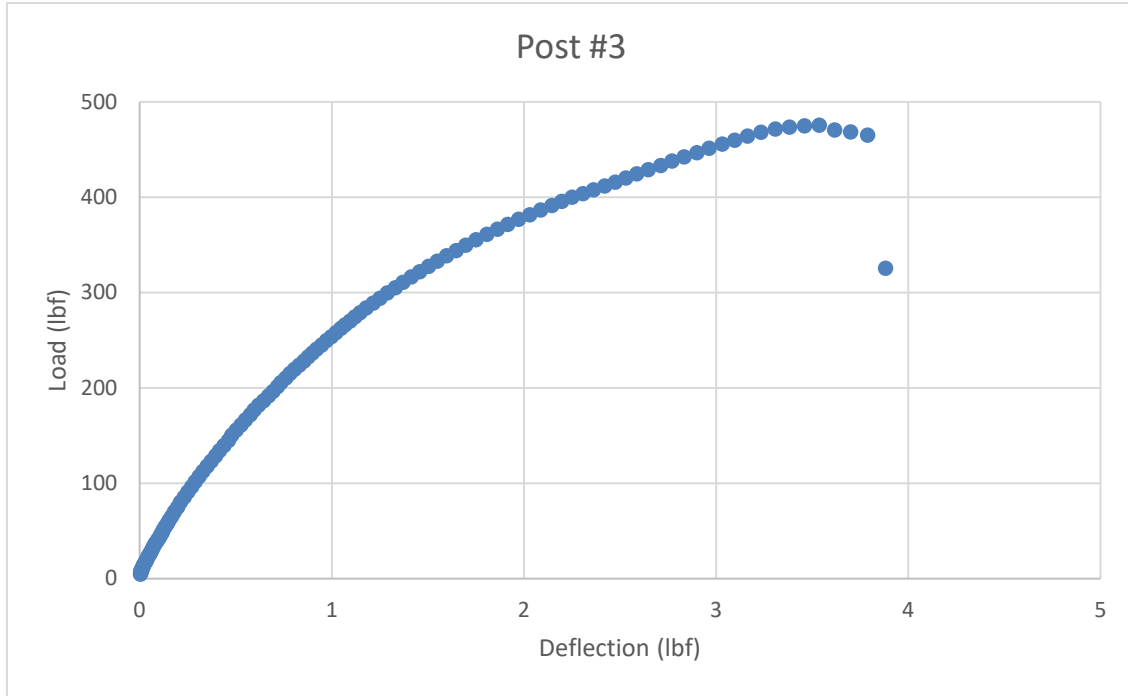
Appendix A - Load vs Deflection Graphs

Post Number	Deflection at 200 lbf (in)	Deflection at Peak Load (in)	Peak Load (lbf)	Failure Mode
1	0.85	4.95	553	Fracture ~1/4" above weld
2	0.87	4.65	541	Fracture ~1/4" above weld
3	0.72	3.53	475	Fracture ~1/4" above weld

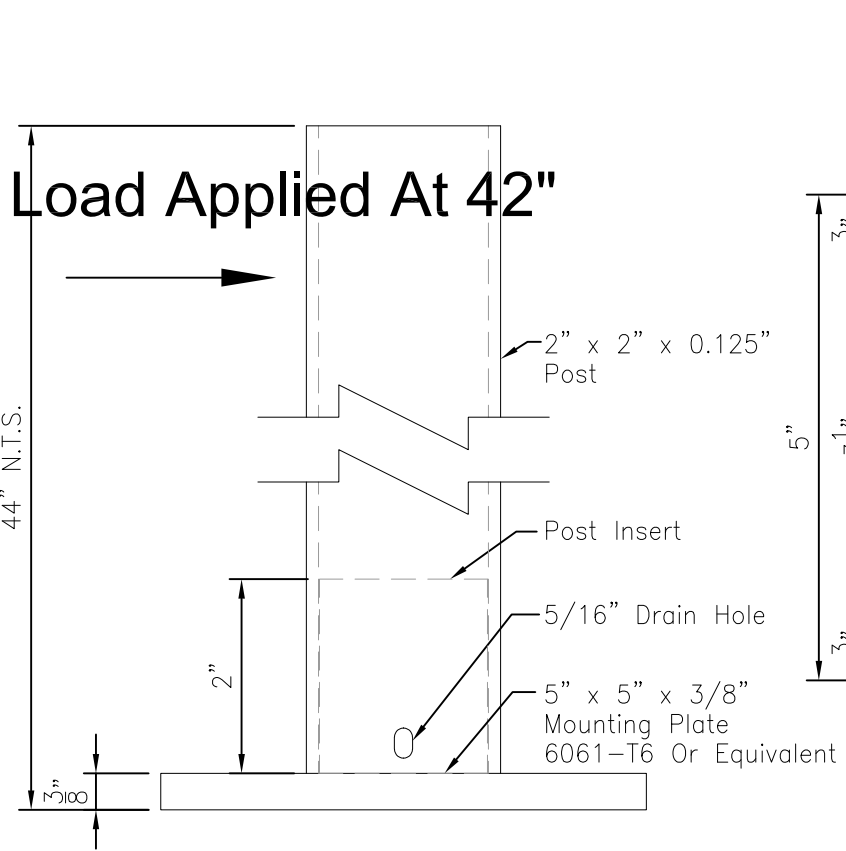
Side View

Project:	Post Testing
Title:	2" Post 5x5 Mounting Plate Detail

Drawing No.	Scale:	6"=1'-0"
Drawn By:	Date:	March 14, 2023
Alloy:	Post No.:	#7
6061-T6

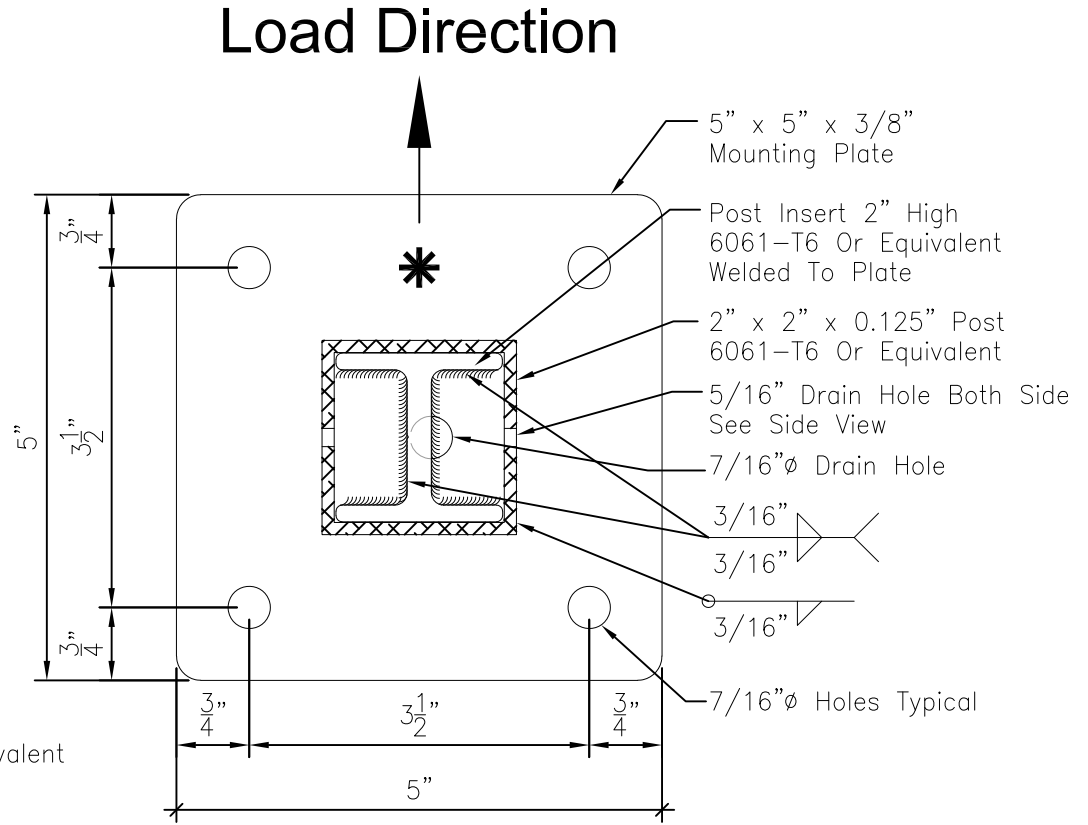
Mounting Plate Detail

Quantity x3
